HURRICANE FRAN EFFECTS ON COMMUNITIES WITH AND WITHOUT SHORE PROTECTION: A CASE STUDY AT SIX NORTH CAROLINA BEACHES

IWR Report 00-R-6

December 2000

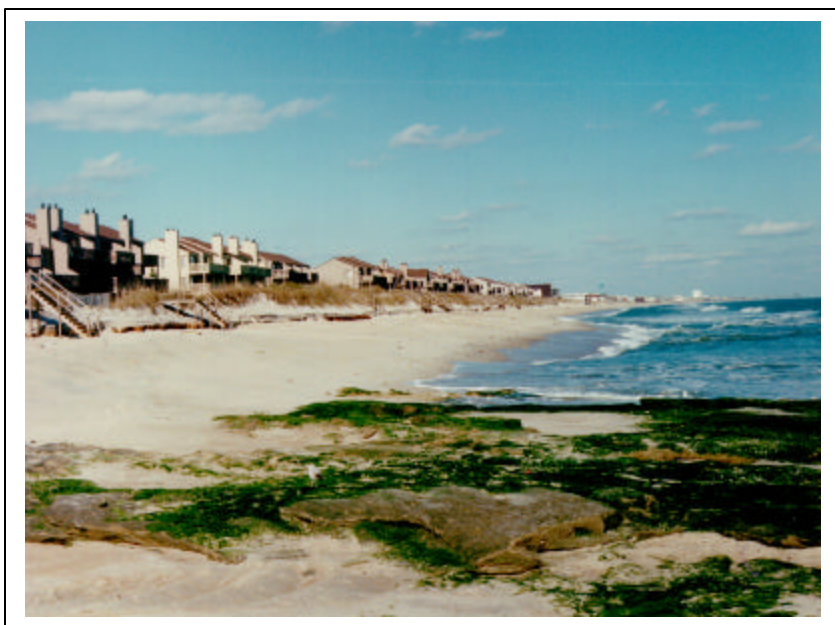
to the higher topography, a natural outcropping of coquina rock fronts the southern end of Kure Beach.

Photo 3D-1: Coquina Rock Outcrop at the Southern end of Kure Beach

- Offshore geology, which varies from Kure Beach to Topsail Island, likely contributed to damages and lack of damages.
 - At the south end of Kure Beach is a Coquina rock outcrop that contributed to the highest of the highwater observed at this location and resulted in an increase in damages.

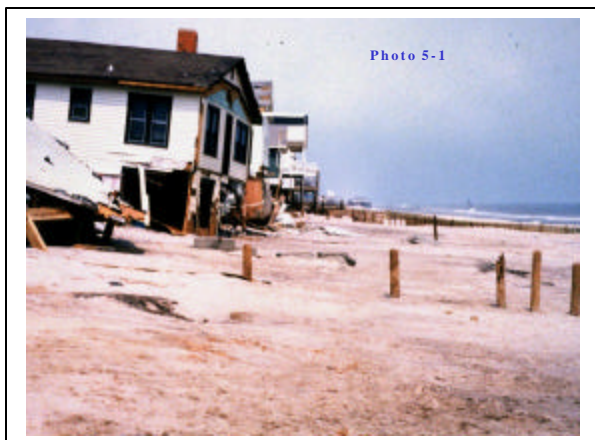
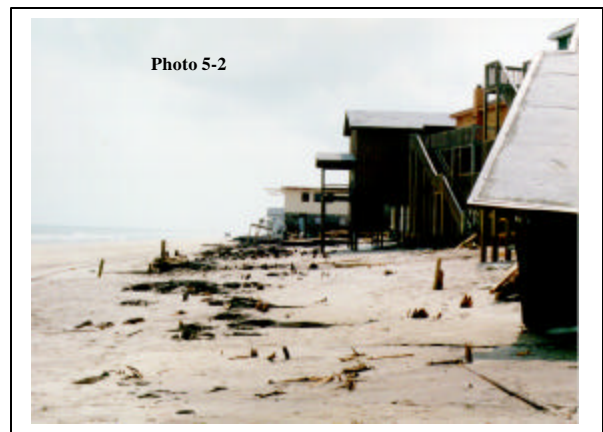
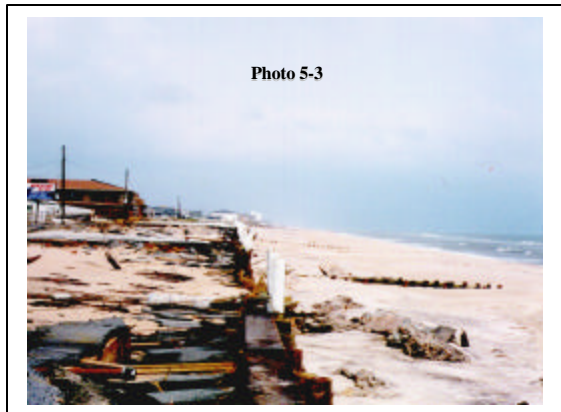
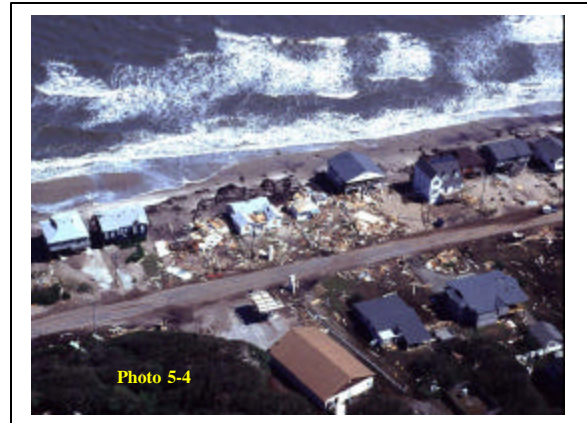
Photos 5-1, -2, -3, -4; Kure Beach after Fran

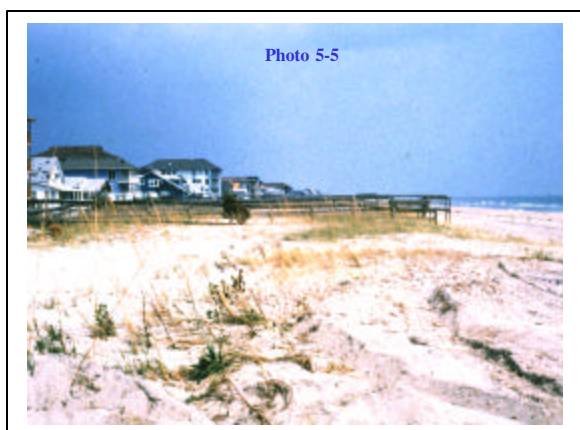
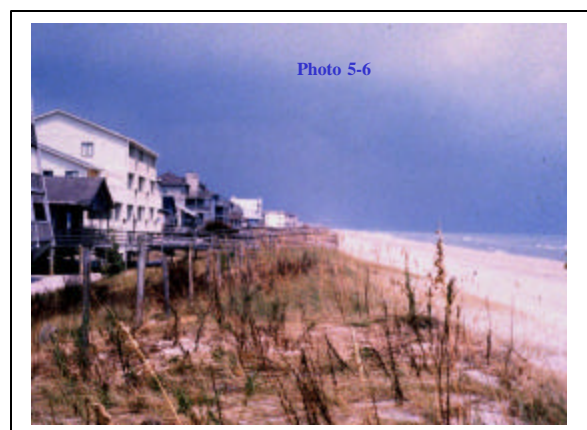
b. Carolina Beach. Structural damage behind the beach fill portion of the protection project fronting Carolina Beach was limited to that caused by wind, rain, and flooding from the sound side. Also, some floodwaters entered the town from the north around the north end of the rubble revetment as well as wave overtopping of the revetment. While the storm surge elevation combined with the accompanying storm waves generally overtopped the dune, the only significant impact of this was the deposition of sand inside the lower floors of ocean front buildings and along the road paralleling the ocean. There was essentially no wave impact damage. Not only did the ocean front structures escape serious damage; the dune walkover structures were not damaged. **Photos 5-5 and 5-6** show the typical condition of Carolina Beach following Hurricane Fran. In Photo 5-5, which was taken in the vicinity of the Boardwalk business area, dune overtopping is evidenced by sand ripples in the dune. In spite of this overtopping, the dune

Photos 5-5 and 5-6; Carolina Beach after Fran

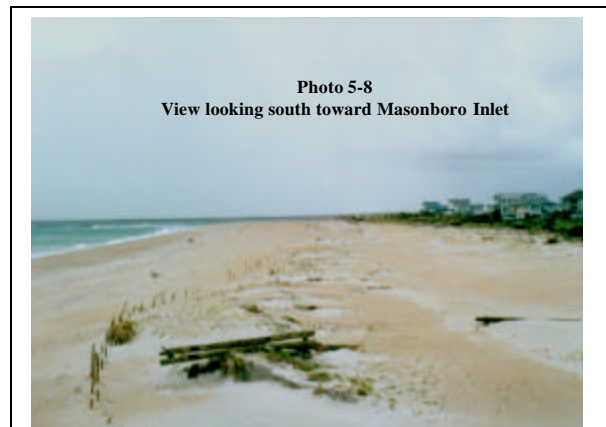
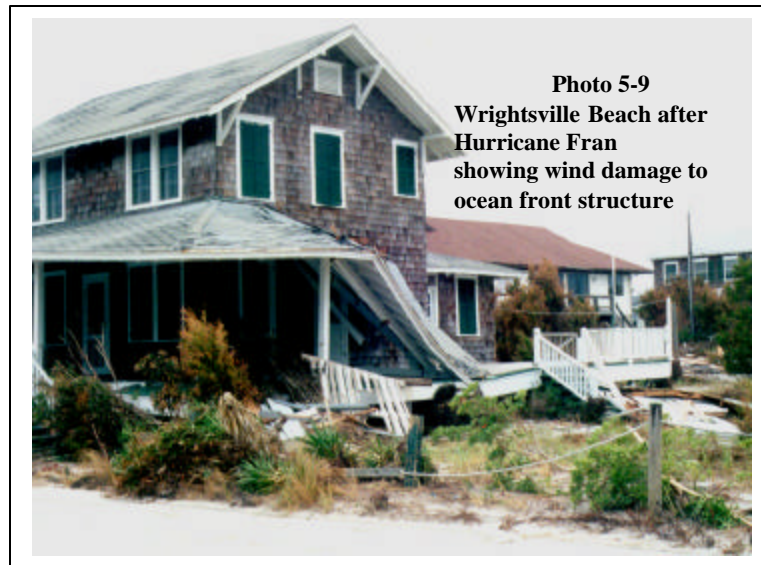
Photos 5-7, -8, and -9; Wrightsville Beach after Fran

Photo 5-9
Wrightsville Beach after
Hurricane Fran
showing wind damage to
ocean front structure

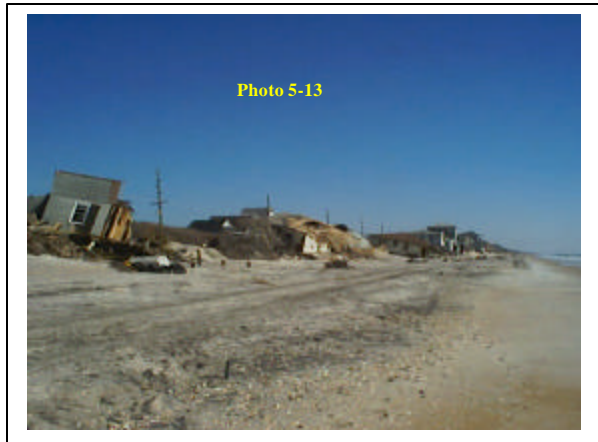
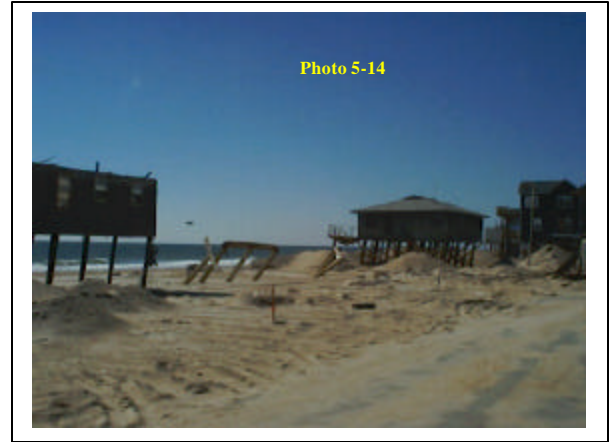
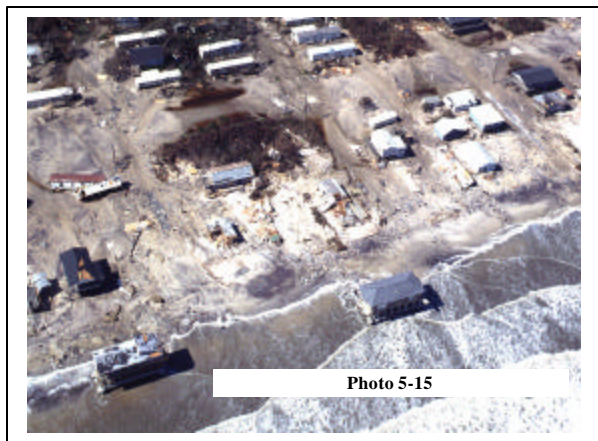
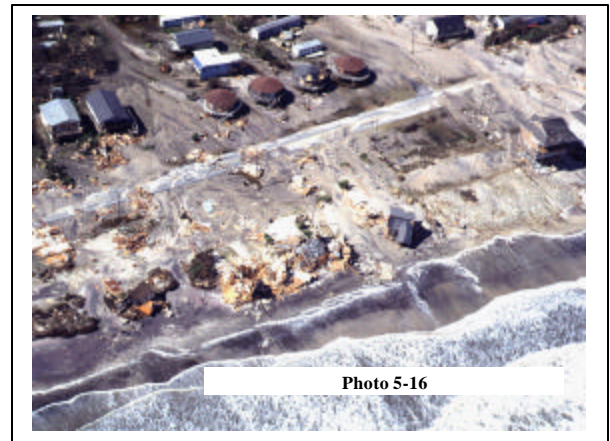
Photos 5-13 through 5-16; Town of North Topsail Beach after Fran

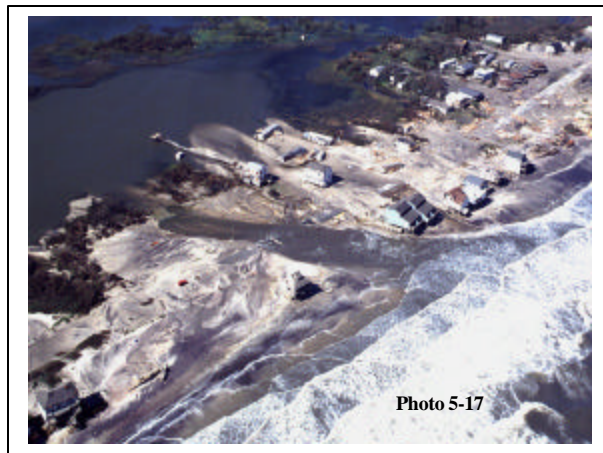
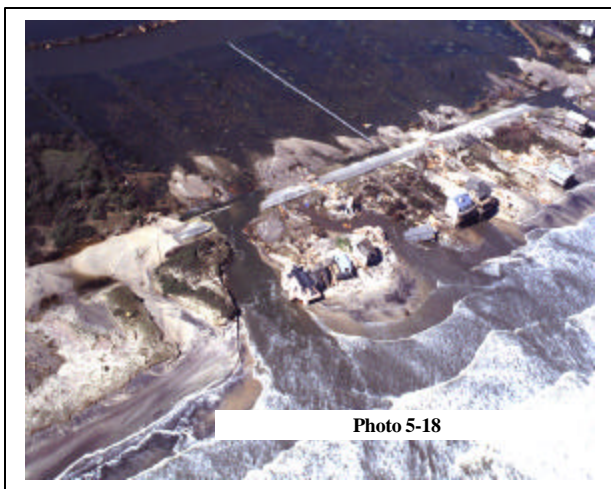
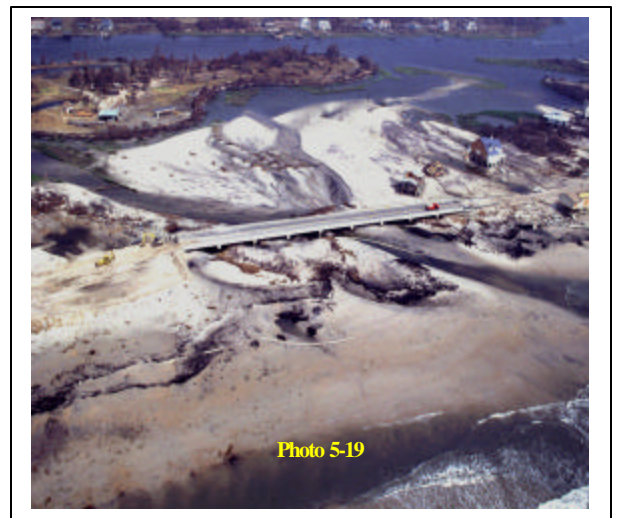
(2). Island Breaches. In addition to the damage to the dune and beach system, Hurricane Fran breached the island in approximately five locations, resulting in the creation of temporary inlets. Emergency work performed by the North Carolina Department of Transportation and the natural recovery of the beach resulted in closure of four of the breaches within a few weeks following the storm. However, the fifth breach, which was located approximately 2-miles south of New River Inlet, remained open for almost a year following Hurricane Fran. **Photo 5-17 and 5-18** show two of the smaller breaches that occurred along North Topsail Beach. **Photo 5-19** shows the northernmost and largest breach. All three photos of the island breaches were made within a few days following the storm. Several of the breaches along North Topsail Beach, including the northernmost breach shown on Photo NTB-7, occurred in low areas which

Photo 5-17, -18 and -19; Breaches at North Topsail Beach following Fran

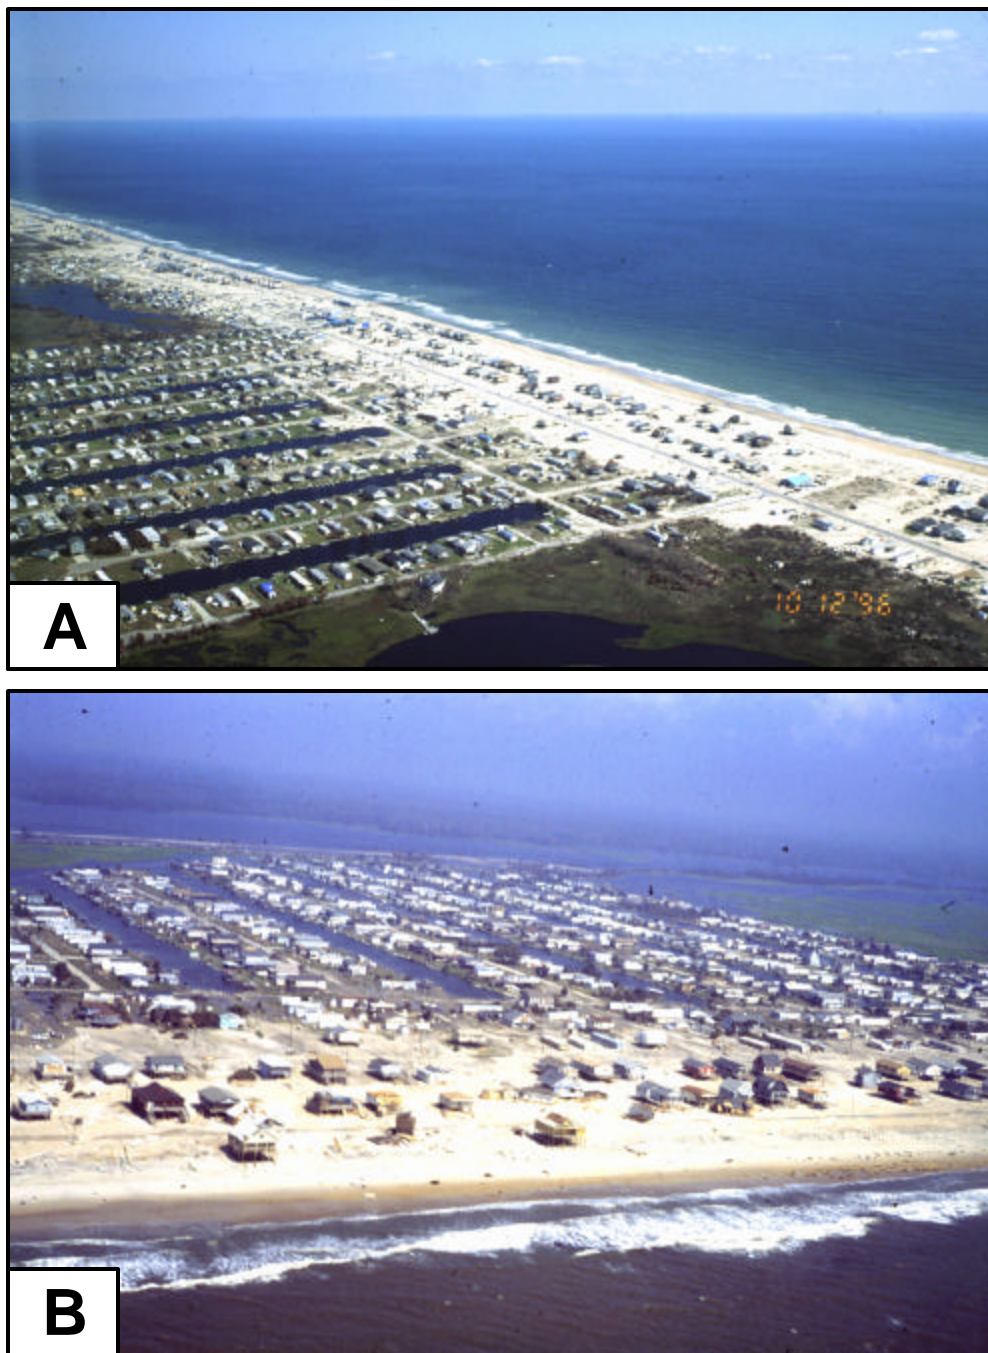
Plate E-5:

Plate 5. Post Hurricane Fran views of Surf City (10/12/96). A.) Seaward view of low area fronting old tidal delta and extensive washover terraces. A number of structures were destroyed along the shoreline segment in the center of the photograph. B.) Landward view of the same area in "A", 0.5 to 1.0m of washover sediment covered the roadbed along much of this section of the town. Note the structural damage along this section of the beach.

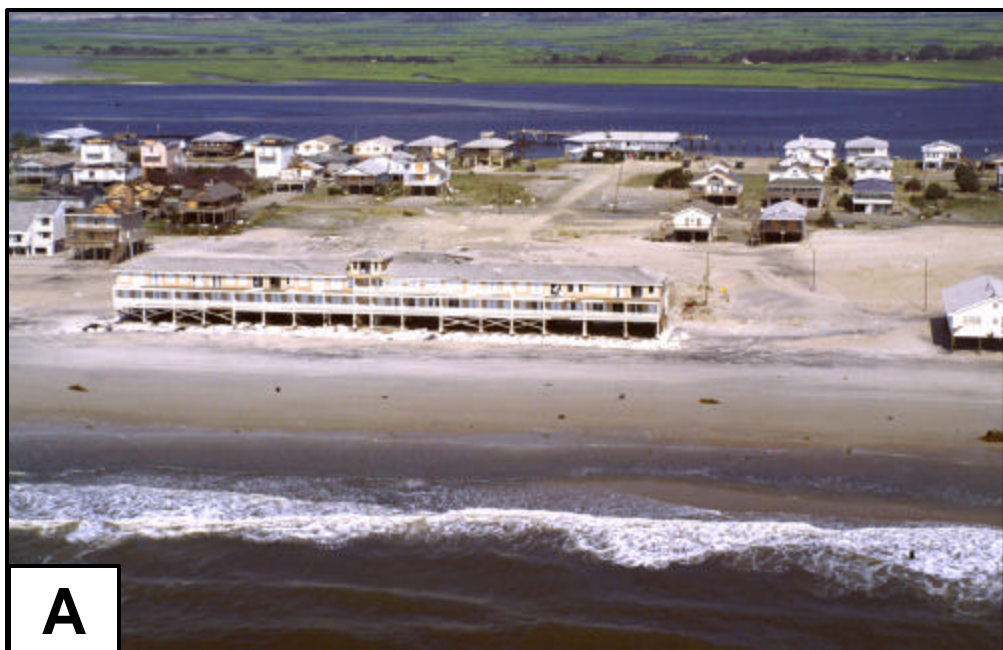
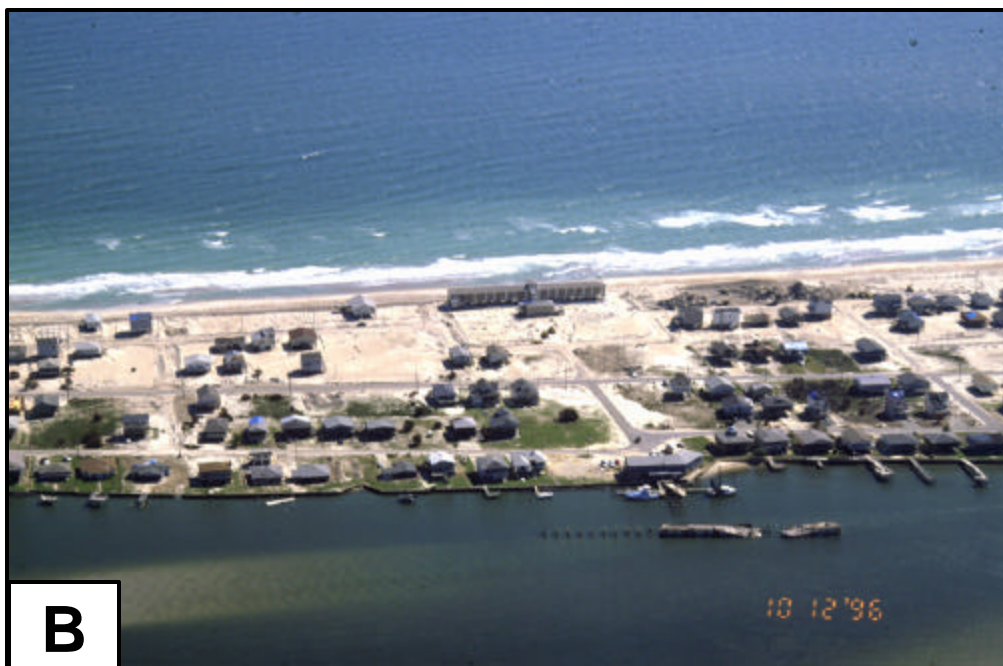
Plate E-6:

Plate 6. Post Hurricane views of Topsail Beach. A.) Sea Vista Hotel along the southern portion of the area is surrounded by an extensive washover terrace that extended beyond the third row of homes (9/7/96). B.) Seaward view of the same area in "A" (10/12/96). Sand has been scraped into a low dune-like feature along most of the southern end of the area. Note the extensive washover terraces developed in this area.

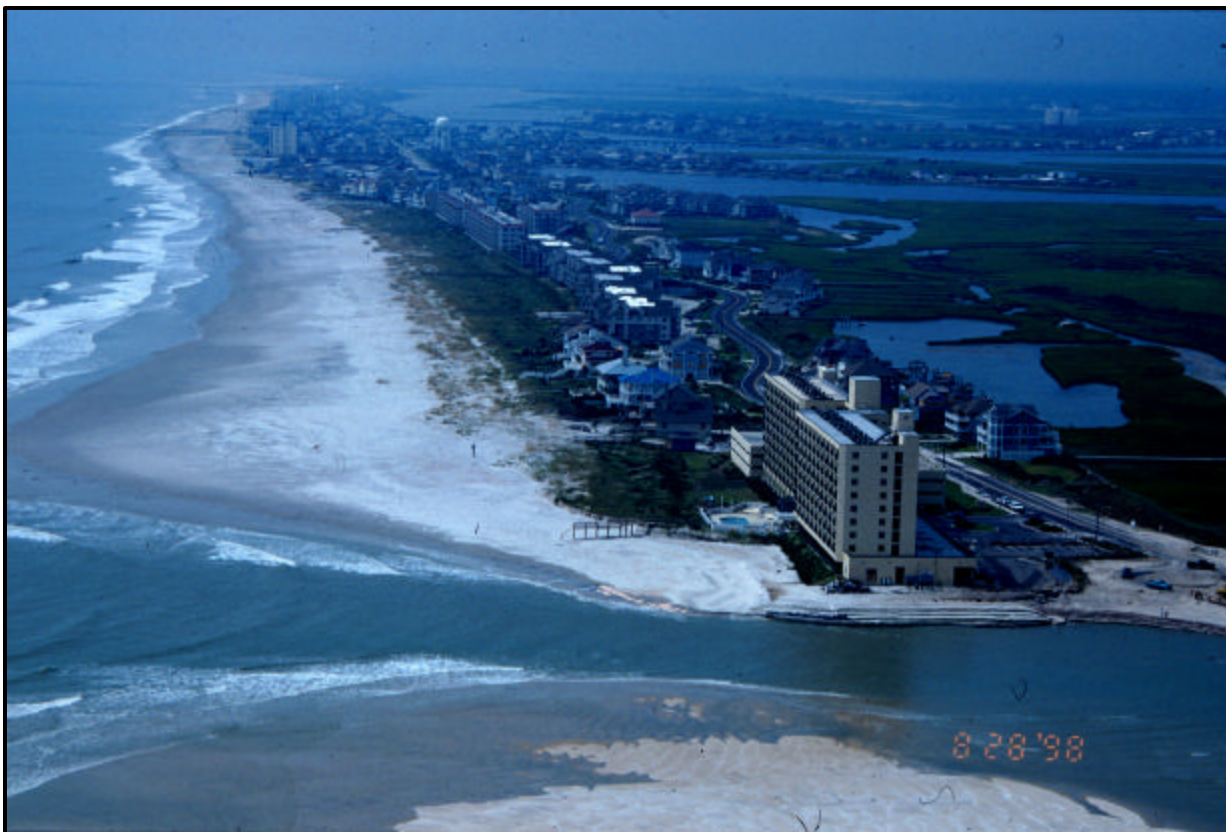
Plate E-8:

Plate 8. South view of Wrightsville Beach after Hurricane Bonnie (8/26/98) and the bump in the shoreline along the mid-barrier section. Note the variations in position of the homes and large multi-unit dwellings along the beach. Most of the chronic erosion and structural damage that is associated with storm events is restricted to this high hazard zone.

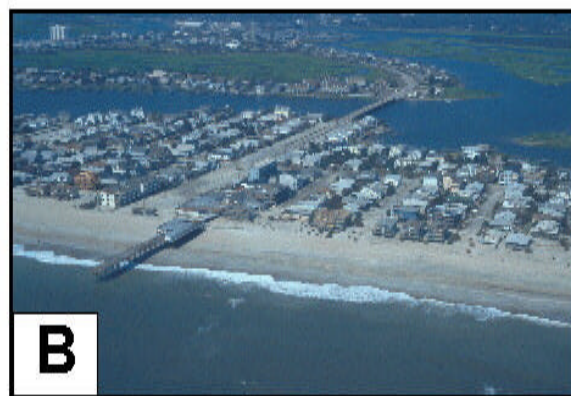
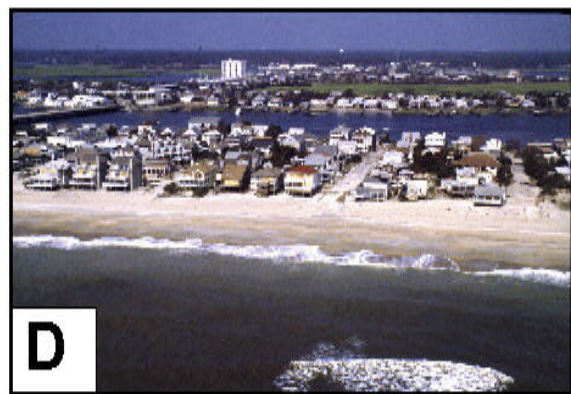
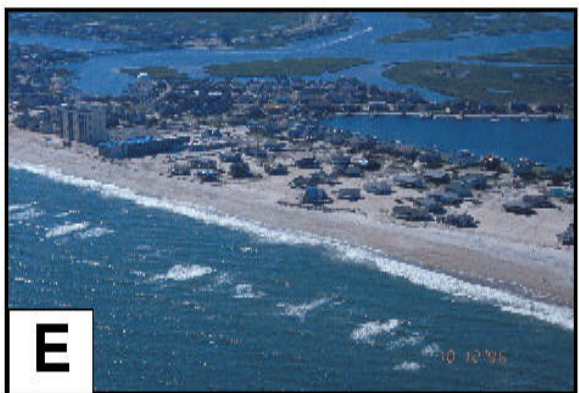
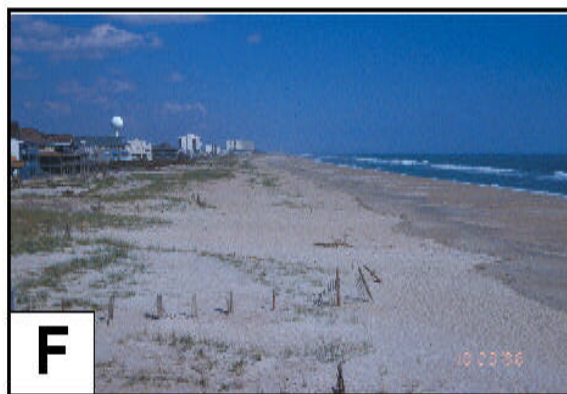
Plate E-9:

Plate 9. Post storm views of Wrightsville Beach. A.) Landward view of south central portion of beach. Little structural damage occurred in this area. Localized overwash is evident. B.) Landward view of shoreline in vicinity of Mercer's Pier. Shoreline north of the pier was susceptible to overwash and minor structural damage was reported in the area. C.) Landward view of prograded shoreline segment near jetty. Little damage was reported in this area due to the wide and high dune field. Localized dune erosion and overwash is evident. D.) Landward view of shoreline south of Mercer's Pier. Minor overwash and minimal damage occurred along this section. E.) Landward view of shoreline in the vicinity of Old Moore's Inlet. The shoreline in this vicinity was the site of the worst structural damage and erosion on Wrightsville Beach due to the poor condition of the beach along the "shoreline bulge". F.) North view of artificial dune/beach almost two months after Hurricane Fran impacted the area. Much of the dune remained in place. Minor washover features are seen along the intact dune.

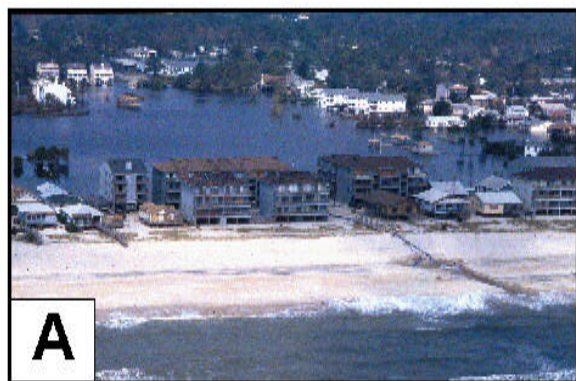
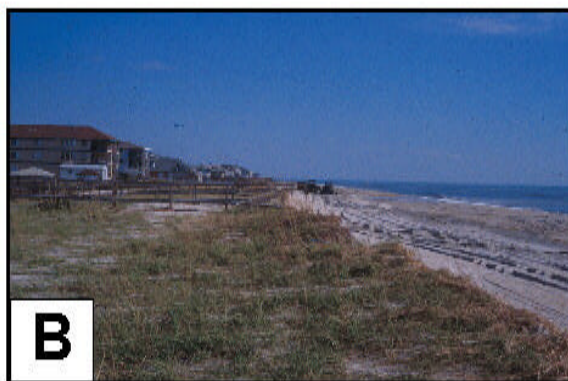
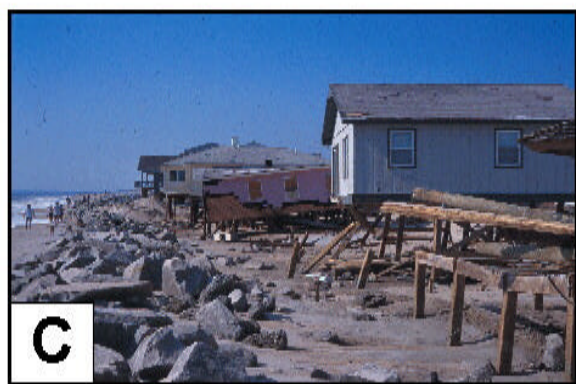
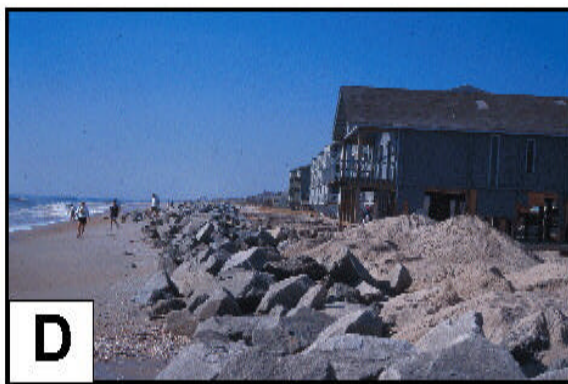
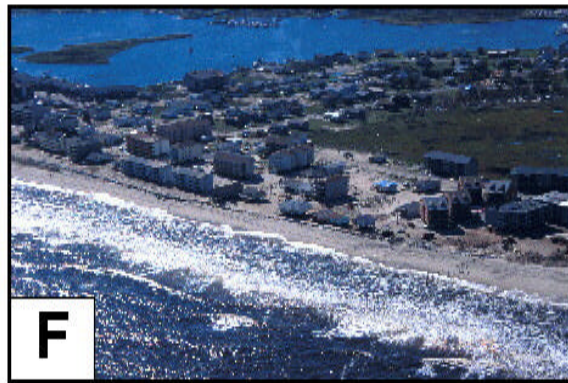
Plate E-11:

Plate11. Post storm views of Carolina Beach. A.) View of Carolina Lake showing eroded dune and flooding of the low -lying area that was once an inlet/lagoon system. B.) North view of eroded artificial dune near the north end of Carolina Beach. Overwash extended across the dune in several places. Damage was minimal. Bulldozing of the profile was common. C.) South view of structural damage near rip-rap at north end of Carolina Beach. D.) Structural damage south of rip-rap was minimal. Overwash extended across the dune and rocks in this area. E.) Air view (10/12/96) one month after Hurricane Fran struck the area. Washover materials were scraped from the roads and placed along the berm/dune system. This area was the site of extensive washover fans. F.) South view of area depicted in "E". Areas not protected by the dune/berm system were overwashed and prone to structural damage.

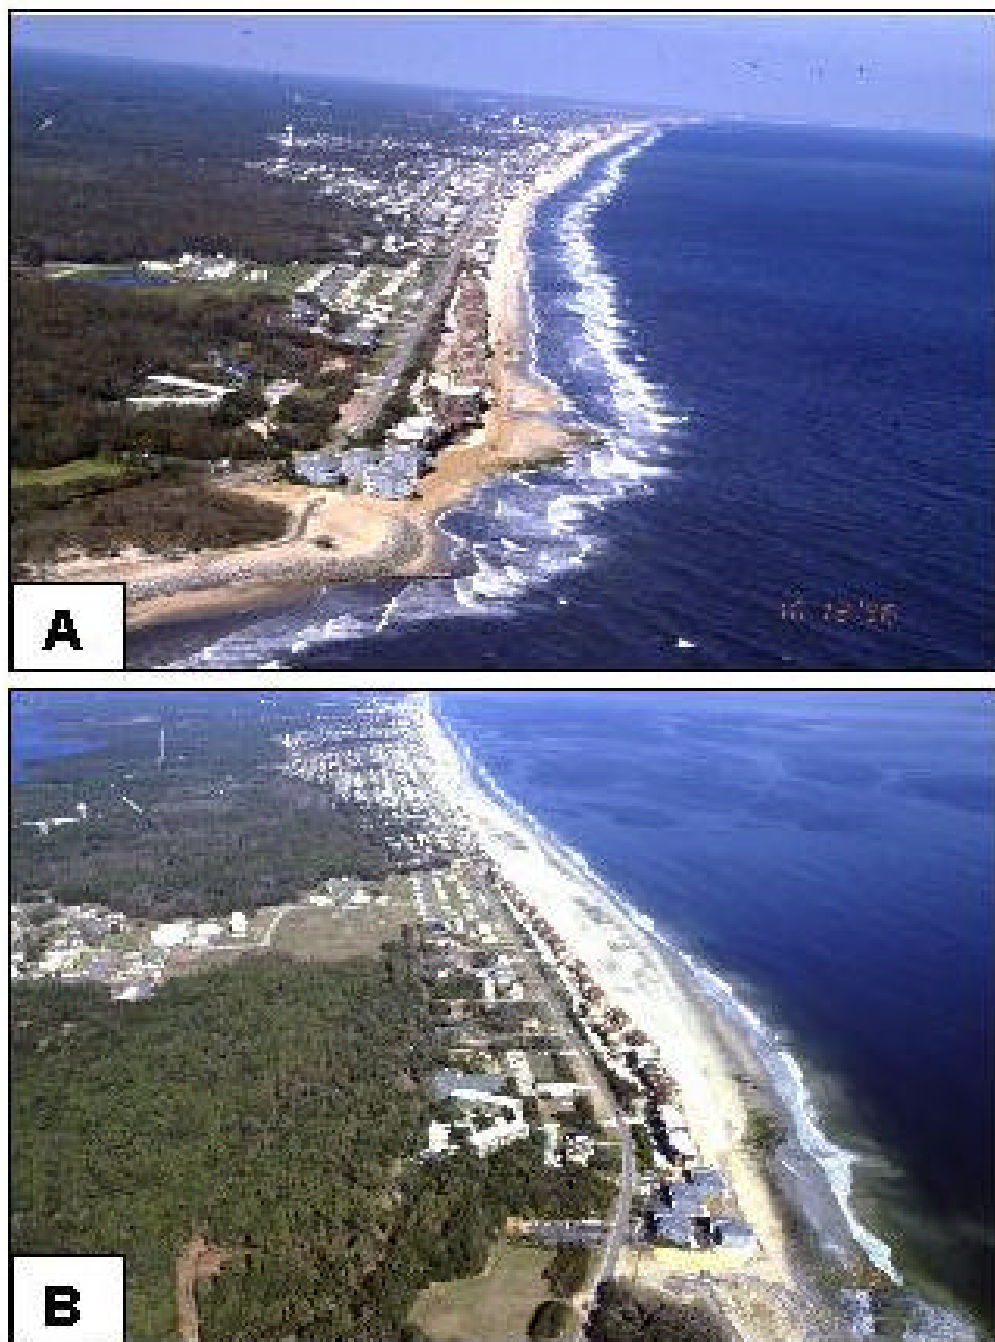
Plate E-12:

Plate 12. North views of the Carolina Beach/Kure Beach subaerial headland shoreline segment. A.) View (10/12/96) from the seawall at Fort fisher shows the narrow beach and the coquina outcropping along the southern section of the area. The erosion resistant calcarenite forms a small protuberance in the shoreline. B.) North view (1/11/98) from the terminus of the seawall at Fort Fisher showing the replenishment project at Kure Beach. Coquina outcrop[is visible at the bottom of the photograph. Beachfill was derived from ancestral channels of the Caer Fear river several miles offshore.

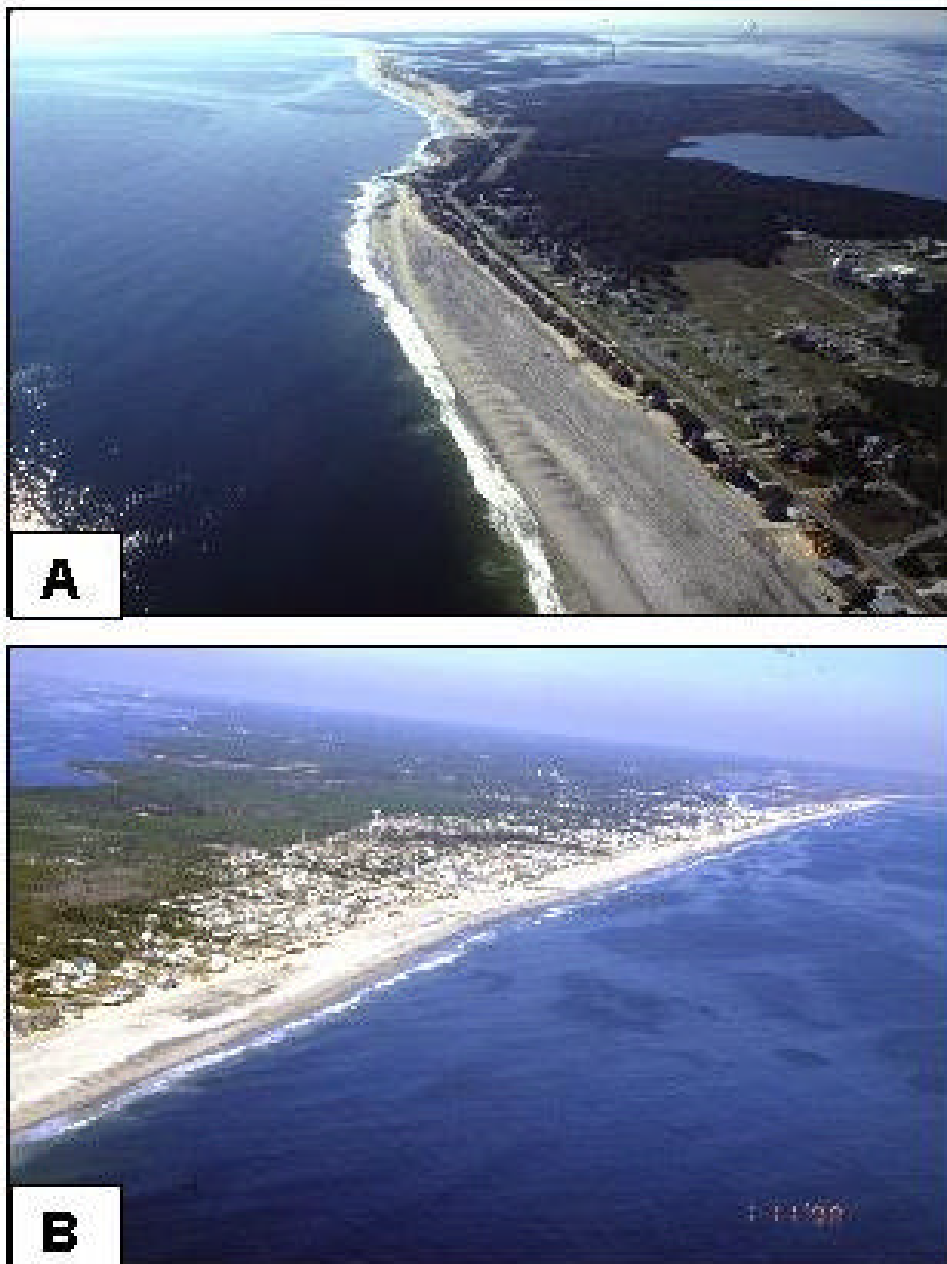
Plate E-14:

Plate 14. Views of replenishment project at Kure Beach. A.) South view (1/11/98) of project and terminus just north of Forth Fisher. Shoreline offset toward top of photo is related to the contrasting nature of the underlying materials. Sheephead Rock is located offshore in upper left corner. B.) Landward view (1/11/98) of northern portion of the replenishment project at Kure Beach and the remainder of the headland segment. Carolina Beach Inlet is seen in the upper right of the view.
